**West Chicago Environmental Response
Trust**

**Final Completion Report – Route
59 Bridge Area**

Kress Creek/West Branch DuPage River Site

November 2013

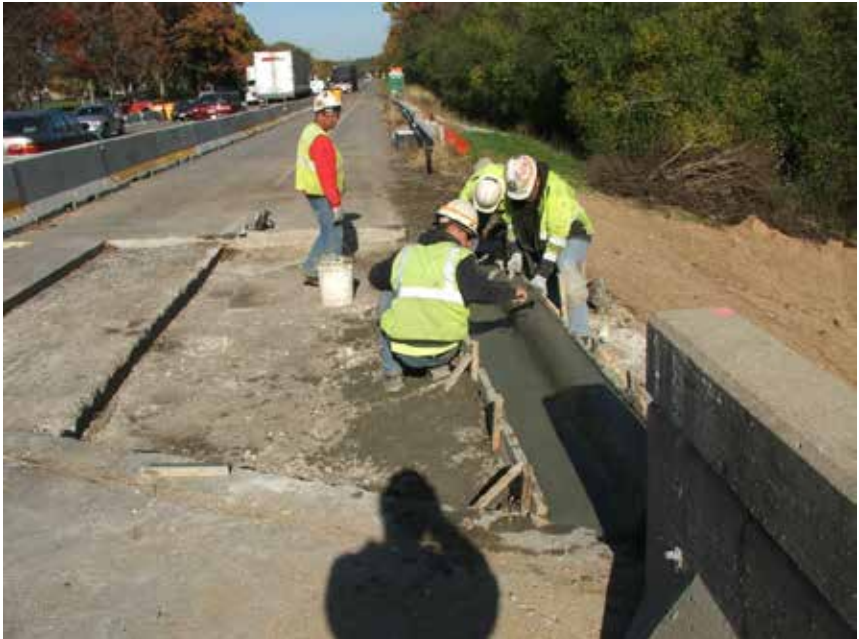
CLIENT: WCERT	SITE NAME: Kress Creek/West Branch DuPage River
PROJECT #: B0071043.0000	SITE LOCATION: DuPage County, IL
PHOTOGRAPH #: 29

DATE: 10/15/12	
DIRECTION: East	
COMMENT: Curb and gutter replacement in southeast corner (R4-2) of Route 59 Bridge Area.

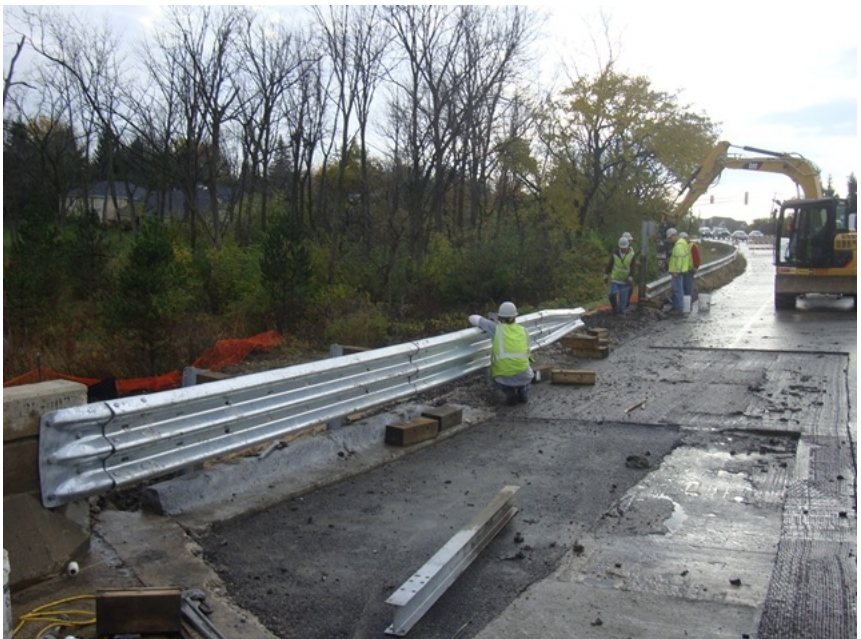
CLIENT: WCERT	SITE NAME: Kress Creek/West Branch DuPage River
PROJECT #: B0071043.0000	SITE LOCATION: DuPage County, IL
PHOTOGRAPH #: 37

DATE: 10/23/12	
DIRECTION: Southwest	
COMMENT: Replacement of guardrails in southwest corner (R4-5) of the Route 59 Bridge Area.
